C-849

November 2, 2020

San Elijo Hills I HOA  
C/o Sandy Punch  
630 San Mario Drive  
Solana Beach, CA 92075

Re: Large *Eucalyptus* tree evaluation - Area B

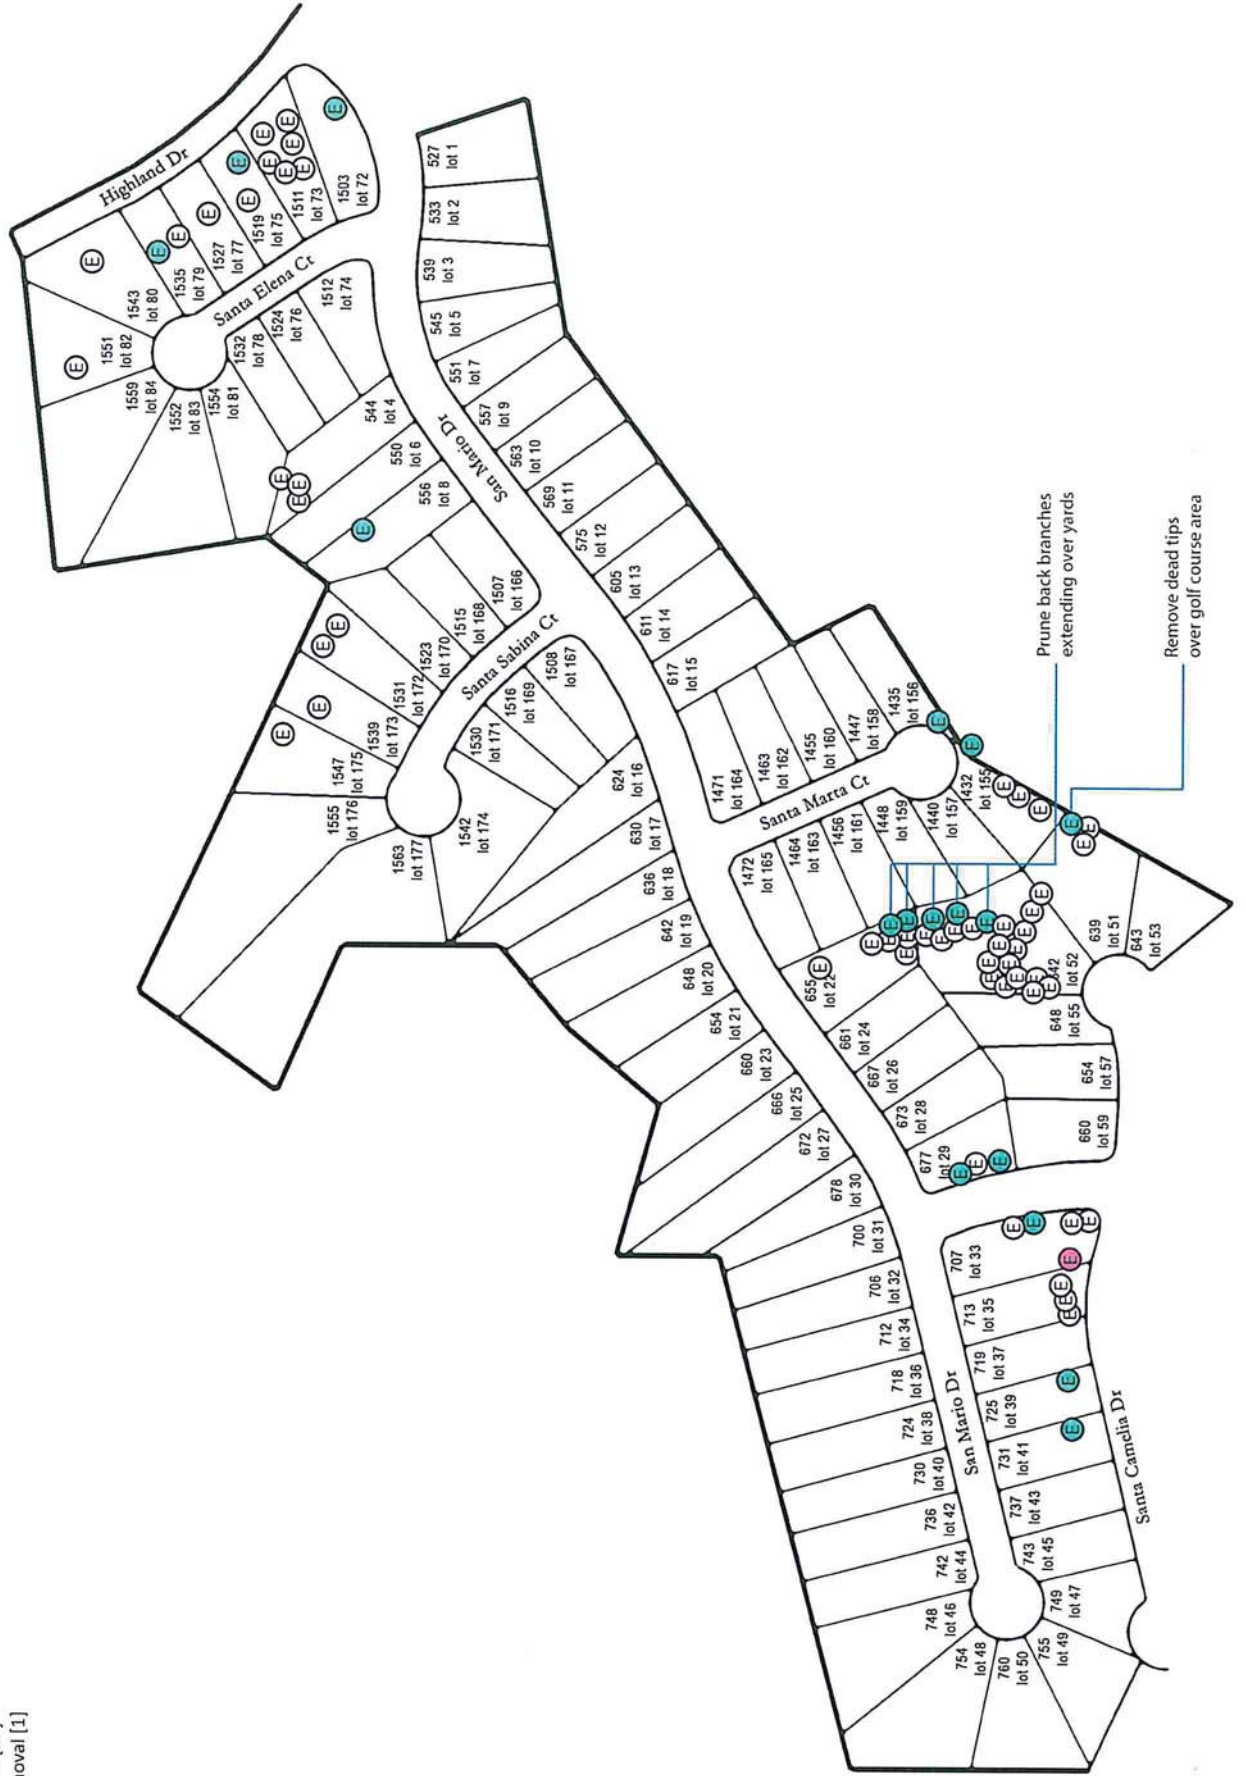
# San Elijo Hills I

The enclosed map includes *approximate* property lines, addresses, lot numbers, and all the large *Eucalyptus* trees currently in Area B. Trees are identified with circles and color-coding, to reflect my current recommendations. Green indicates a pruning recommendation, red indicates a removal recommendation. If there is no color shade, then there is no action recommended at this time.

In Area B, there are approximately 70 large eucalyptus trees. I have recommended 17 for pruning and 1 for removal. The pruning specification is either for Crown thinning by approximately 25% (especially the heavy ends on many of the trees) or specialized pruning as indicated on the map. The removals should be cut to a low stump.

Crown thinning includes the removal of dead, dying, diseased, crowded, weakly attached, and low-vigor branches and watersprouts from a tree crown as well as the selective removal of live branches to increase light penetration and air movement into the crown. This selective live branch removal should include branches *2 inches in diameter or less*. It is preferred that many smaller branches be removed during a thinning process than fewer larger branches. Increased light and air stimulates and maintains interior foliage, which in turn improves branch taper and strength. Thinning reduces the wind sail effect of the crown and the weight of heavy limbs. In general, the trees should be pruned in such a way as to maintain their natural structure and shape. Pruning should be performed to enhance the safety, health and beauty of the trees and should comply with sound arboricultural practices for the particular species of tree(s) being pruned.
