September 6, 2024

Re: Large *Eucalyptus* Tree Evaluation - Area B

San Elijo Hills I

2024 Tree Maintenance

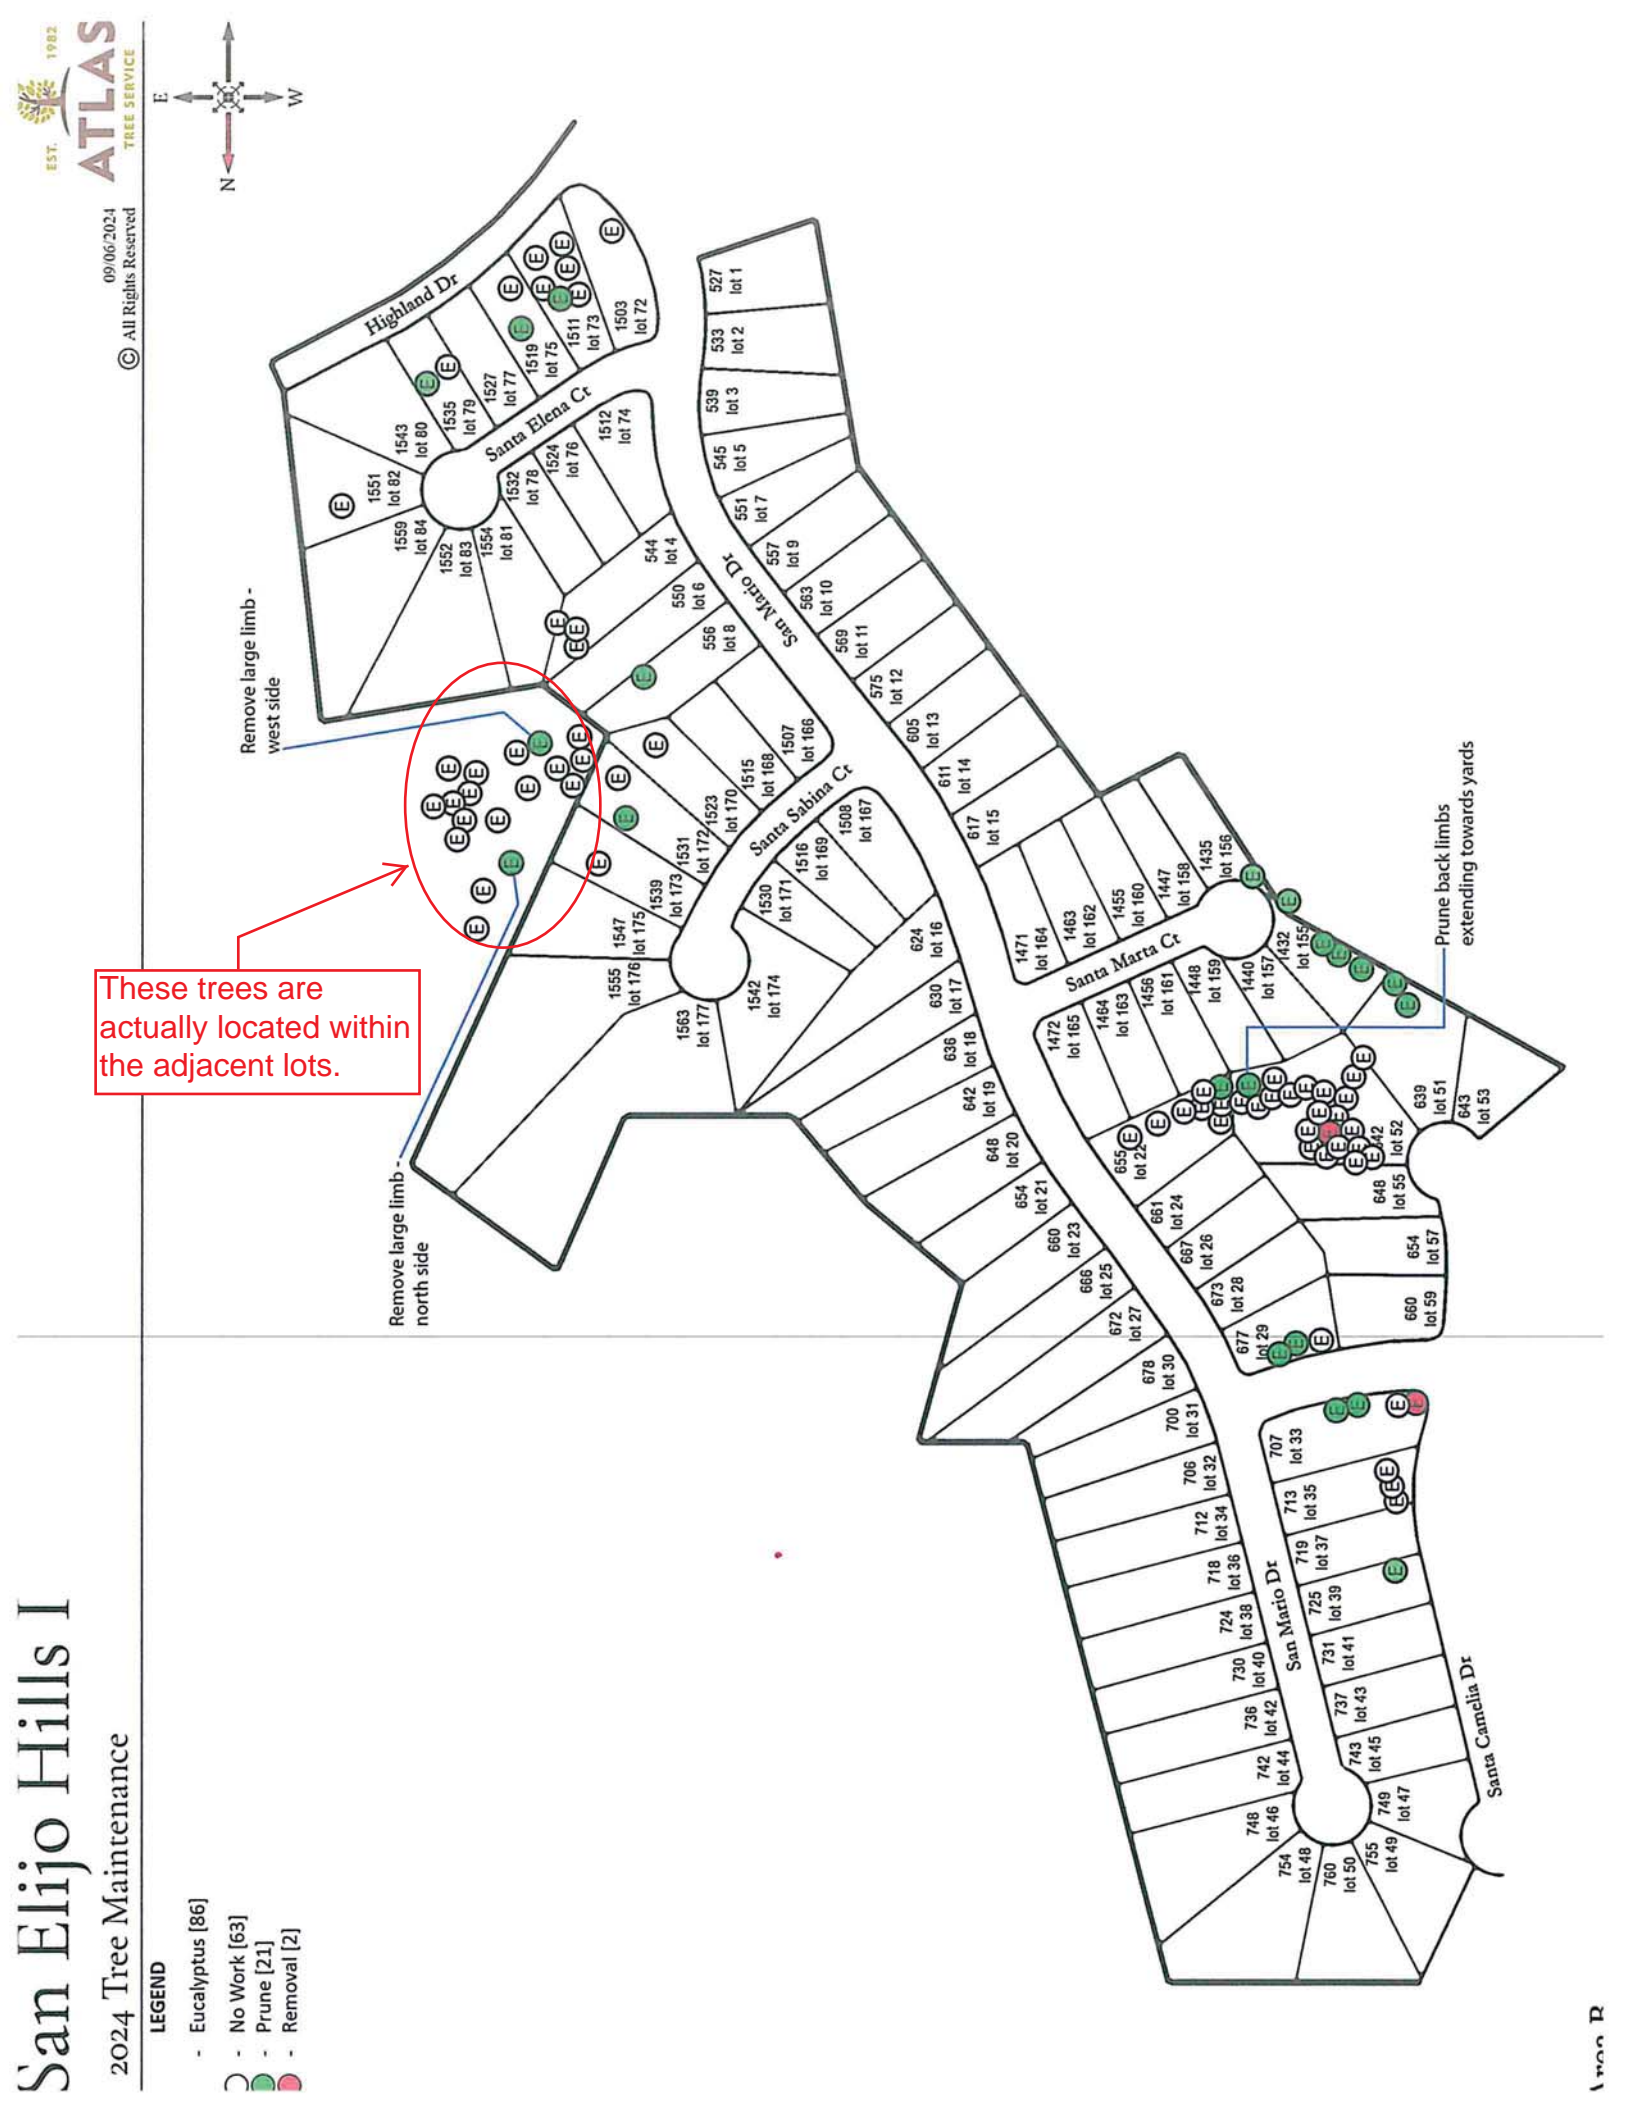
The enclosed map provides approximate property lines, addresses, lot numbers, and identifies all the large *Eucalyptus* trees currently in Area B. Trees are marked with circles and color-coded to indicate my recommendations: green signifies a pruning recommendation, red indicates a removal recommendation, and unshaded circles reflect that no action is recommended at this time. In Area A, the only tree recommended for action is the dead *Eucalyptus* located behind Lots 183/184. Please refer to the site maps for further details and specific tree locations.

In Area B, there are approximately 86 large eucalyptus trees (trees were added this year, as directed, on the north slope behind Santa Sabina Court). I have recommended 21 for pruning and two for removal. The pruning specification is for Crown thinning by

approximately 25% (especially the heavy ends on many of the trees). The removals should be cut to a low stump (near ground level).

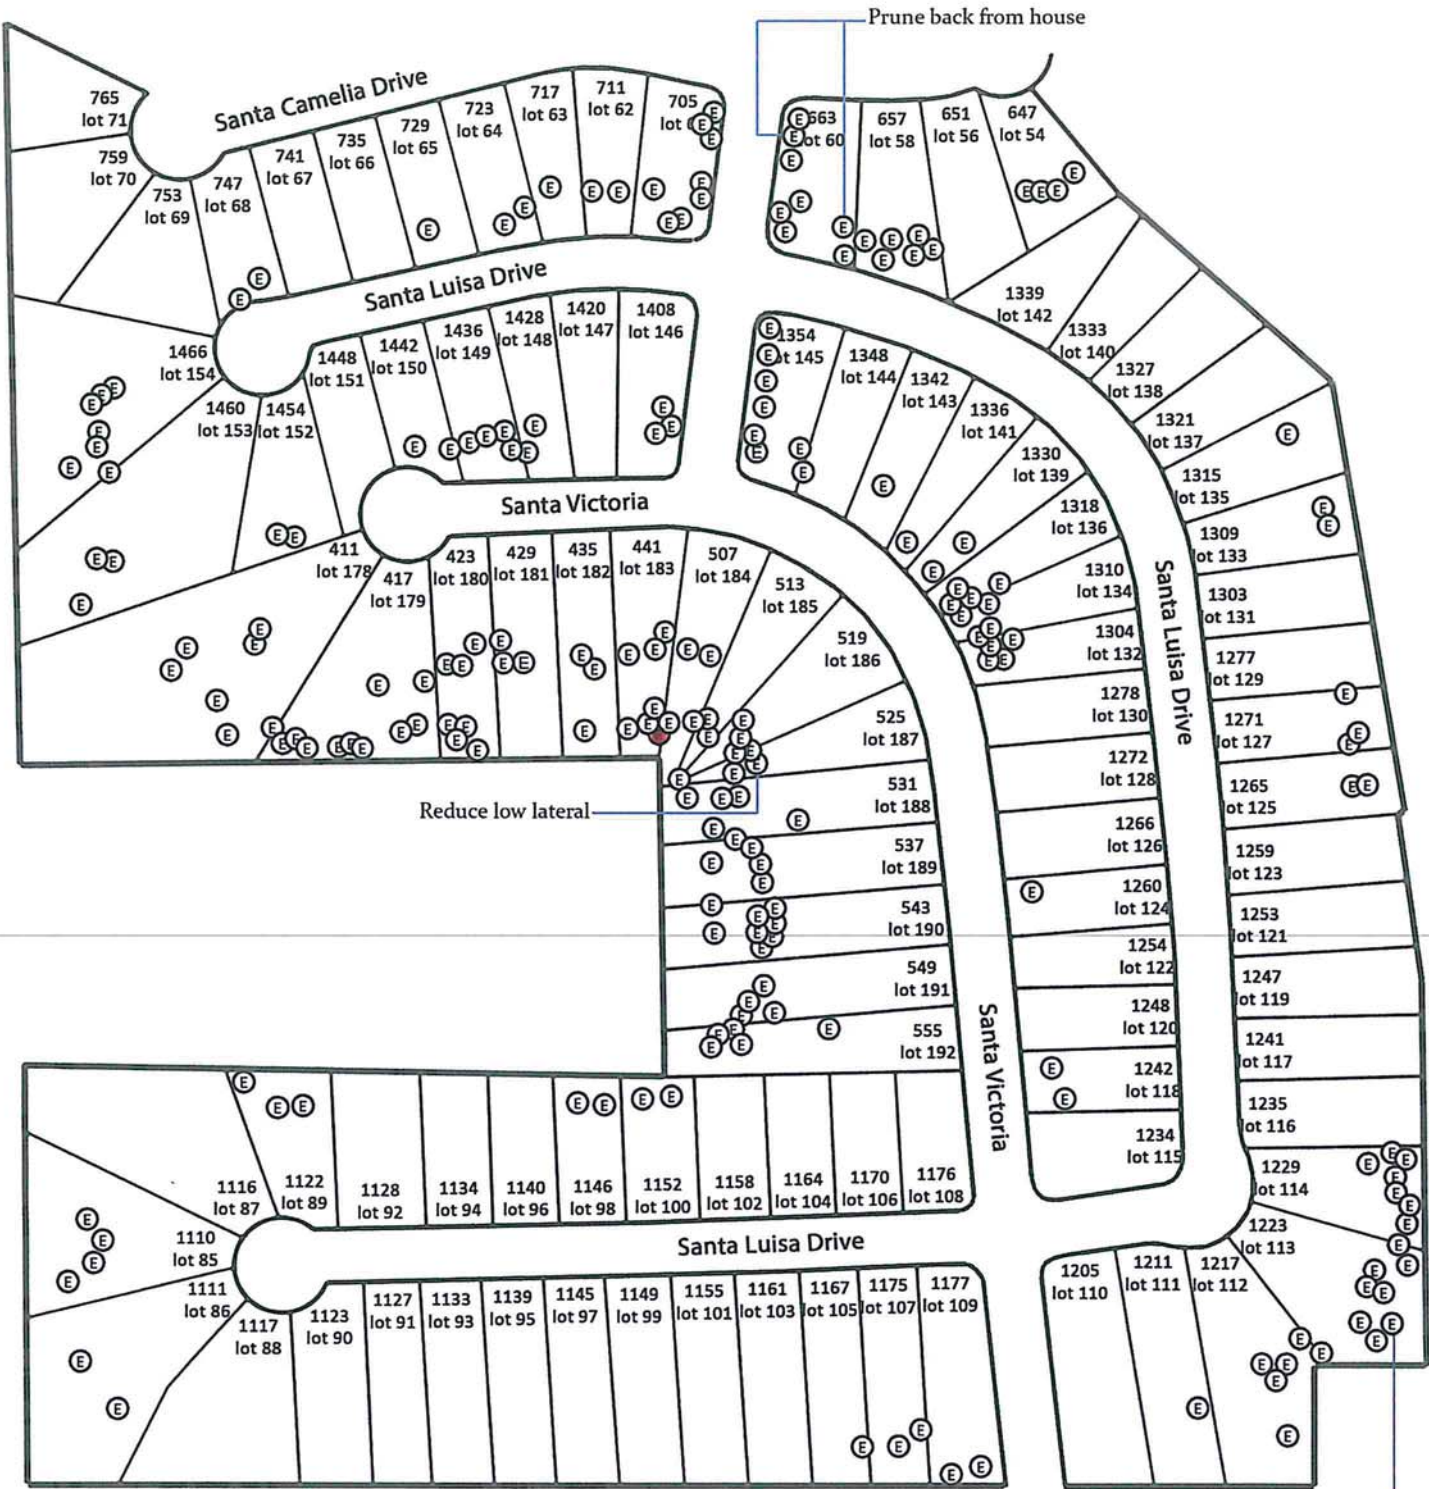
San Elijo Hills I - Area A

In addition to the *Eucalyptus* trees in Area B, we also inspected four specific tree-related concerns located in Area A, on the west side of the association. These issues were brought to my attention during the walk, and we collectively assessed their current status and discussed potential recommendations. The findings and recommended actions for both Area B (prune 21 trees and remove 2 trees) and Area A (remove one tree) are included in this report for your review and further action.
