September 3, 2025

Re: Large *Eucalyptus* Tree Evaluation - Area A

# San Elijo Hills I - Area A

Large / Slope Eucalyptus Locations; 2025 Assessment (August)

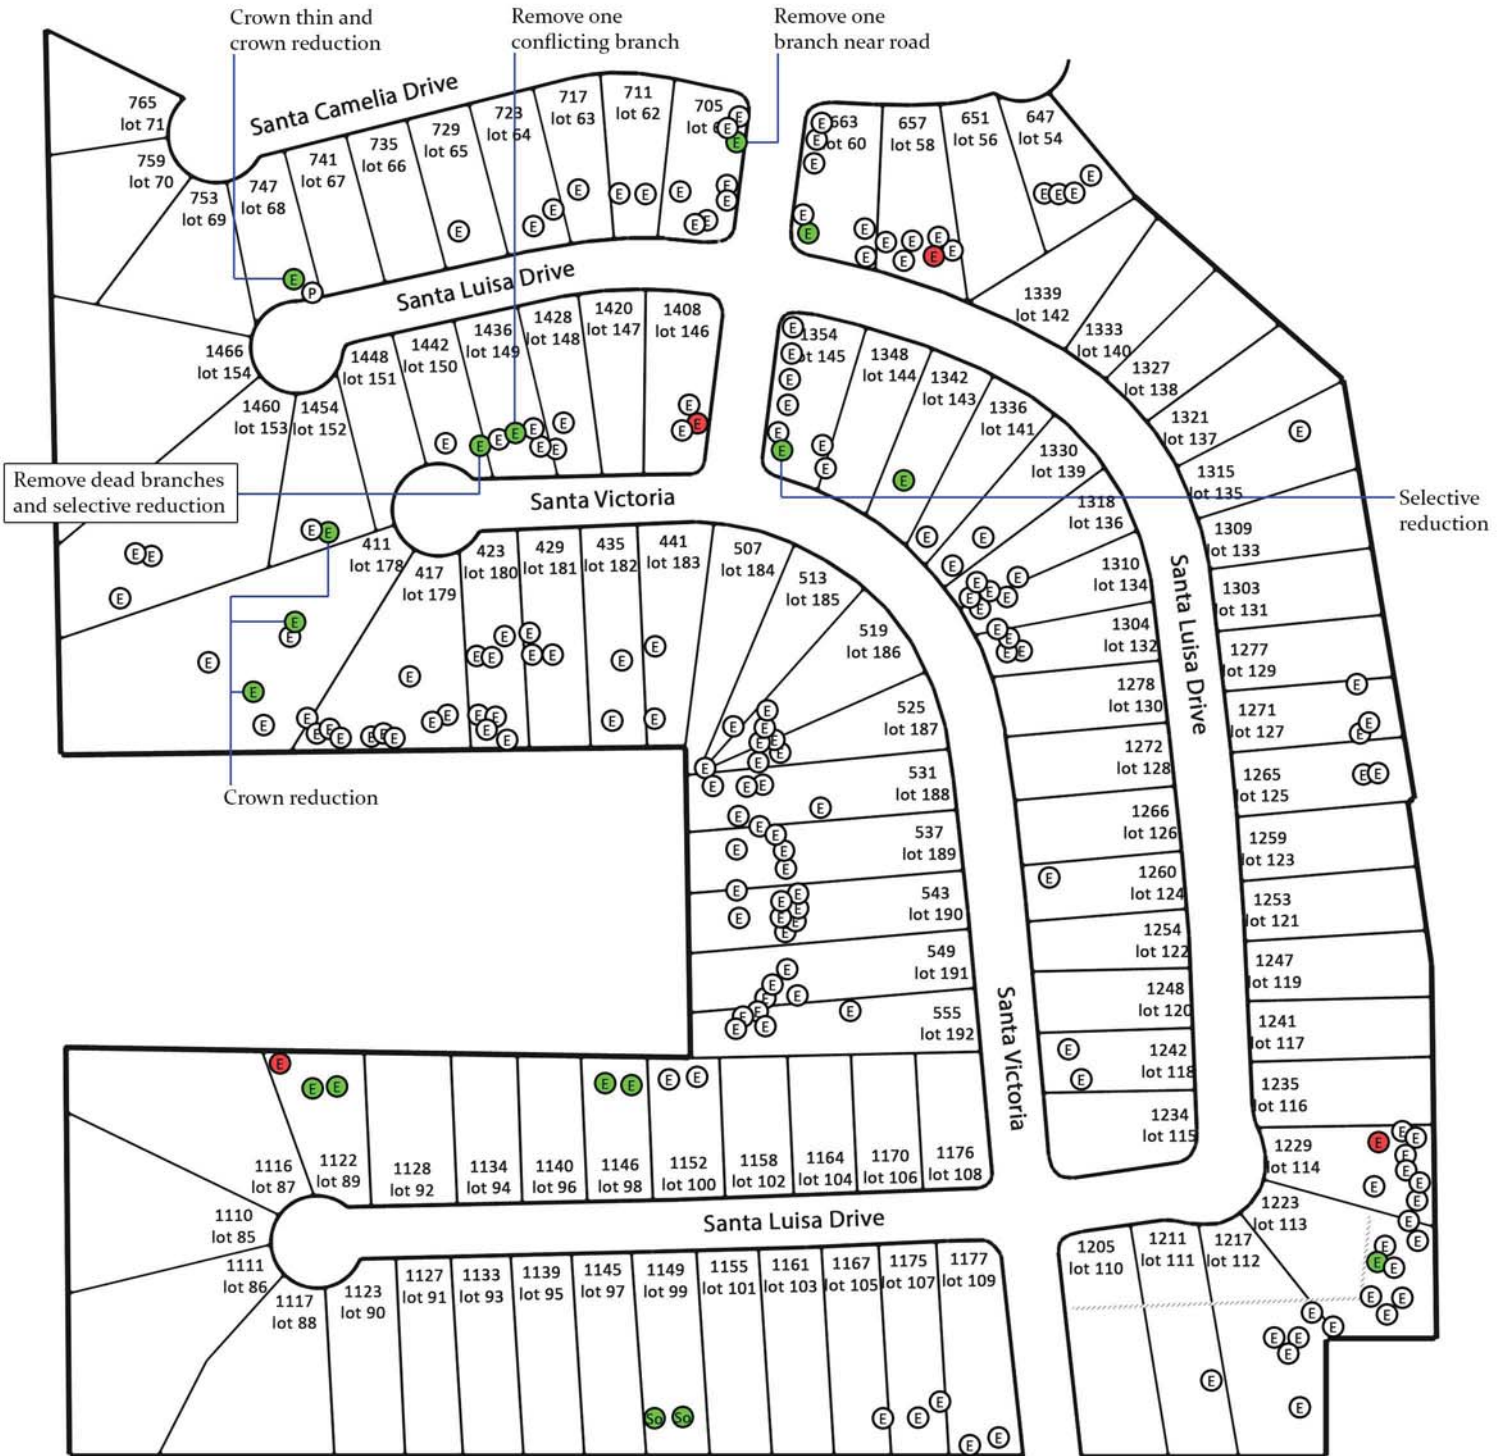
In Area A, there are approximately 178 large eucalyptus trees. I have recommended 17 for pruning and four (4) for removal. The pruning specification is for Crown thinning by approximately 25% (especially the heavy ends on many of the trees). I have also recommended Crown reduction on certain trees. If labeled for Selective Reduction, that is to mean that only a portion of the overall crown is to be reduced (this was reviewed with the contractor during the site walk). The removals should be cut to a low stump (near ground level).
